TECHNICAL REPORT

NO. C-701

MODEL CE-150

CE-150 Printer
Eliminating Paper Feed Failure during the
Printout of the Smallest Character

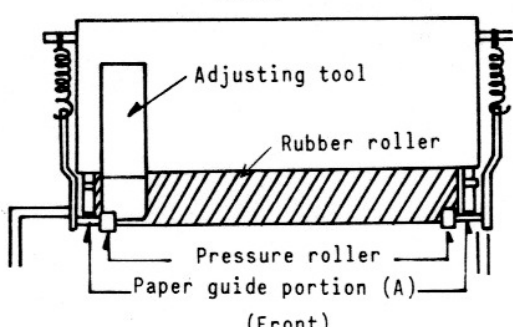
<p>(Front)</p><p>Fig. 1</p></div> <p>(2) Slide in the adjusting tool along the rubber roller to check if the paper guide portion (A) (See Figs. 1 and 4) does not move. This has to be done for paper guides on both sides.</p> <div>

Adjusting method	(1) Insert the adjusting tool between the rubber roller and the pressure roller.
	<div><p>(Rear)</p>

Measures	Adjust the clearance between the paper guide and the rubber roller using the adjusting tool. For the details of adjustment, refer to Page 2, 3.
Machines	<p>It applies to the printer of which lot number is described below (some of the January, 1982, production machines).</p> <p>* Lot numbers</p> <p>203152 203162 203222 204153 205153 205163 205223</p> <p>However, those which marked with a black "V" and a green dot (.) are excluded.</p> <div style="display: flex; align-items: center; justify-content: center;">

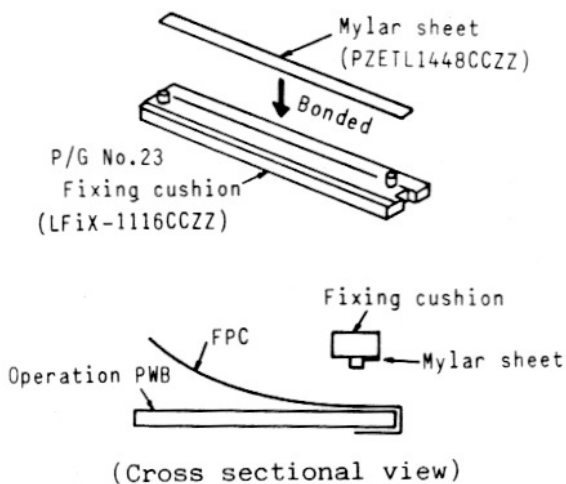
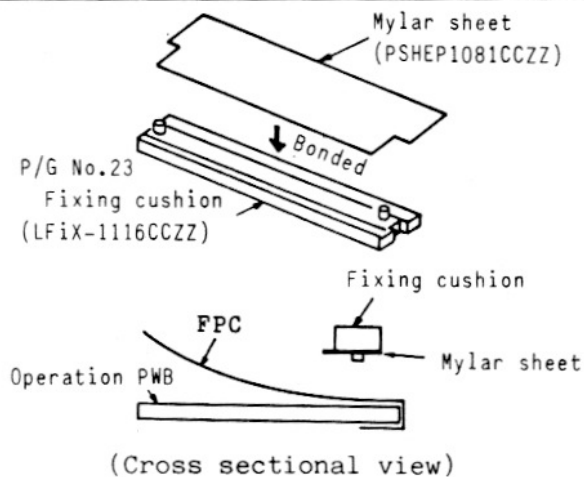
8. Structural change
